**State of Louisiana  
Department of Natural Resources  
Coastal Engineering Division**

**2006/2007 Annual Inspection  
Report**

**LITTLE VERMILION BAY  
SEDIMENT TRAPPING  
PROJECT (TV-12)**

March 6, 2007  
Vermilion Parish

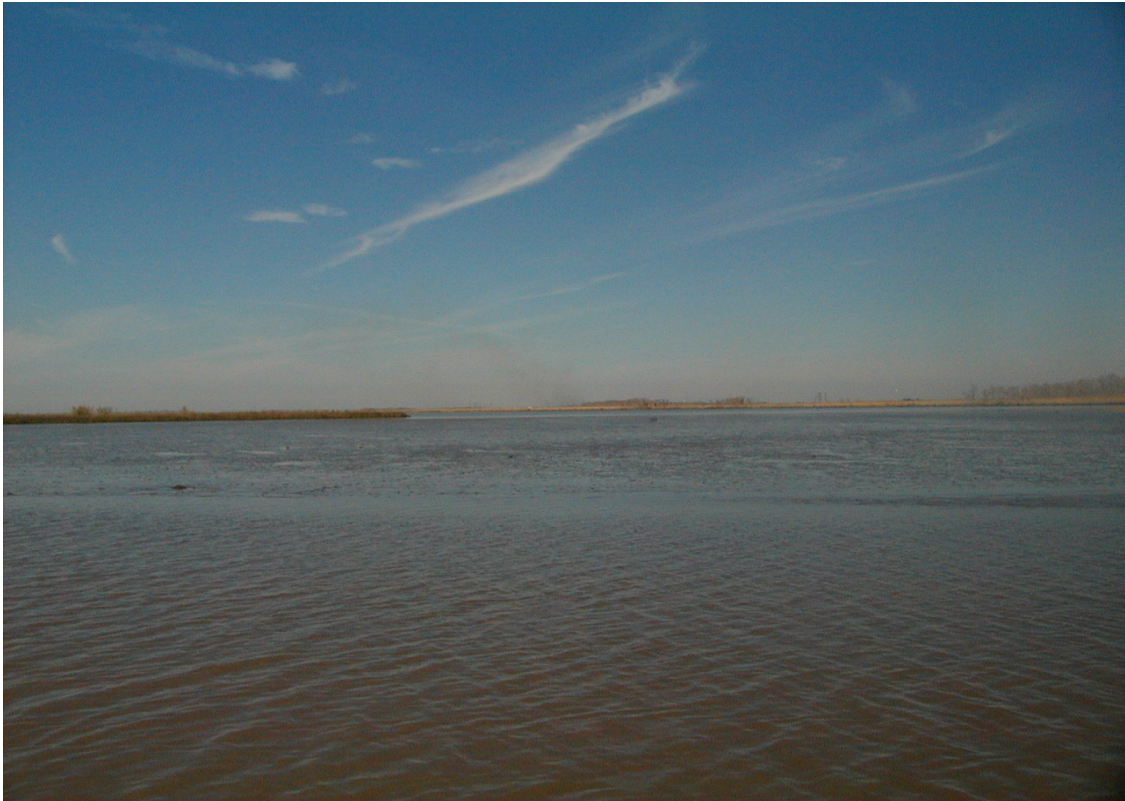
The terraces appear to be in excellent condition. Water elevation was not available at the time of this inspection. Staff gauges will need to be re-established in the area. Some erosion has taken place on the southern most terraces but not nearly as severely as anticipated. The southwestern most terraces have nearly eroded away. Water levels in this borrow canal have silted in significantly since the hurricanes.

Although not a component of the project, it should be noted that the entrance from Freshwater Bayou into Little Vermilion Bay continues to widen due to boat traffic on Freshwater Bayou. No visible erosion, however, has taken place on the northern terraces as a result of this widening. (Photos: Appendix B, Photo 1-2)

**Photo 1**—accretion/vegetation between terraces

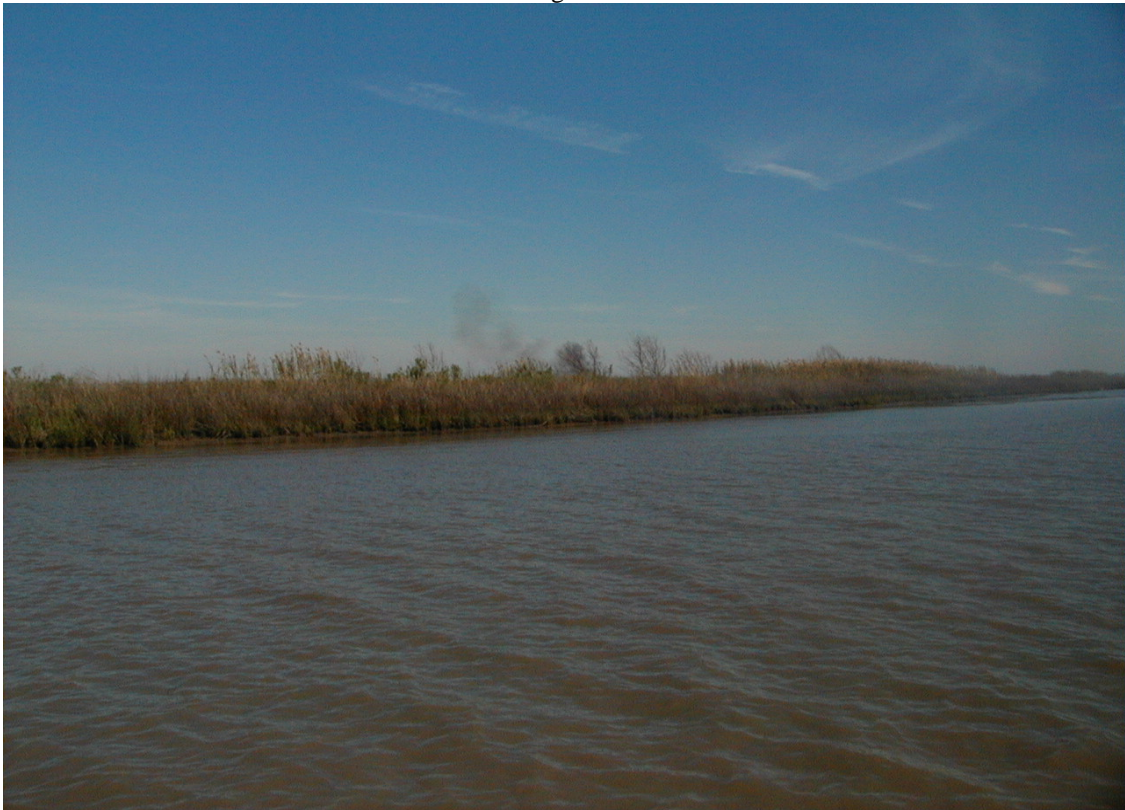
Vegetation planted on the terraces has recovered from the stress caused by the hurricanes. No maintenance needed at this time.

**Photo 2**—typical vegetated terrace
